## KABELLÖSUNG

Neu bei METZGER:  
Ölstopp-Kabel für Anschlussleitung  
Nockenwellenversteller Mercedes-Benz: A 271 150 27 33

## CABLE SOLUTION

Oil stop cable for connecting lead camshaft adjuster  
Mercedes Benz: A 271 150 27 33

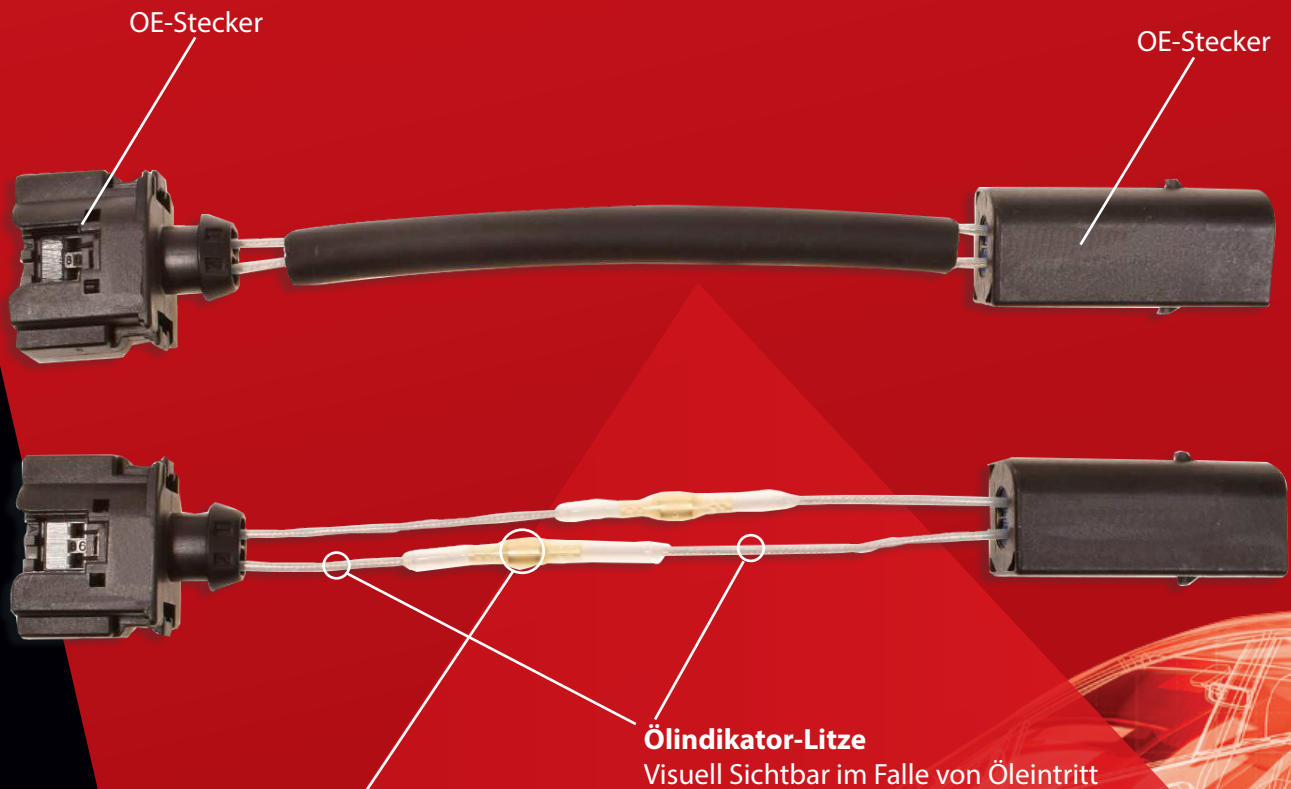
### Innovation: Ölstoppteitungsverbinder Ölindikator-Litze

Der Ölverlust am Nockenwellenversteller ist bei bestimmten Mercedes-Benz Motoren ein bekanntes Problem. Durch die Kapillarwirkung kann das Öl im Kabelbaum bis zum Steuergerät gelangen. Dies kann zum Ausfall der Elektronik führen. Durch das Metzger „Ölstoppkabel“ wird ein Eindringen von Öl in den Kabelbaum wirksam verhindert.

#### Ölstoppleitungsverbinder

- Korrosionsfrei
- Verbindungstechnologie gemäß
  - Norm DIN EN 60352-2
  - VW Norm Group Standard VW 60330

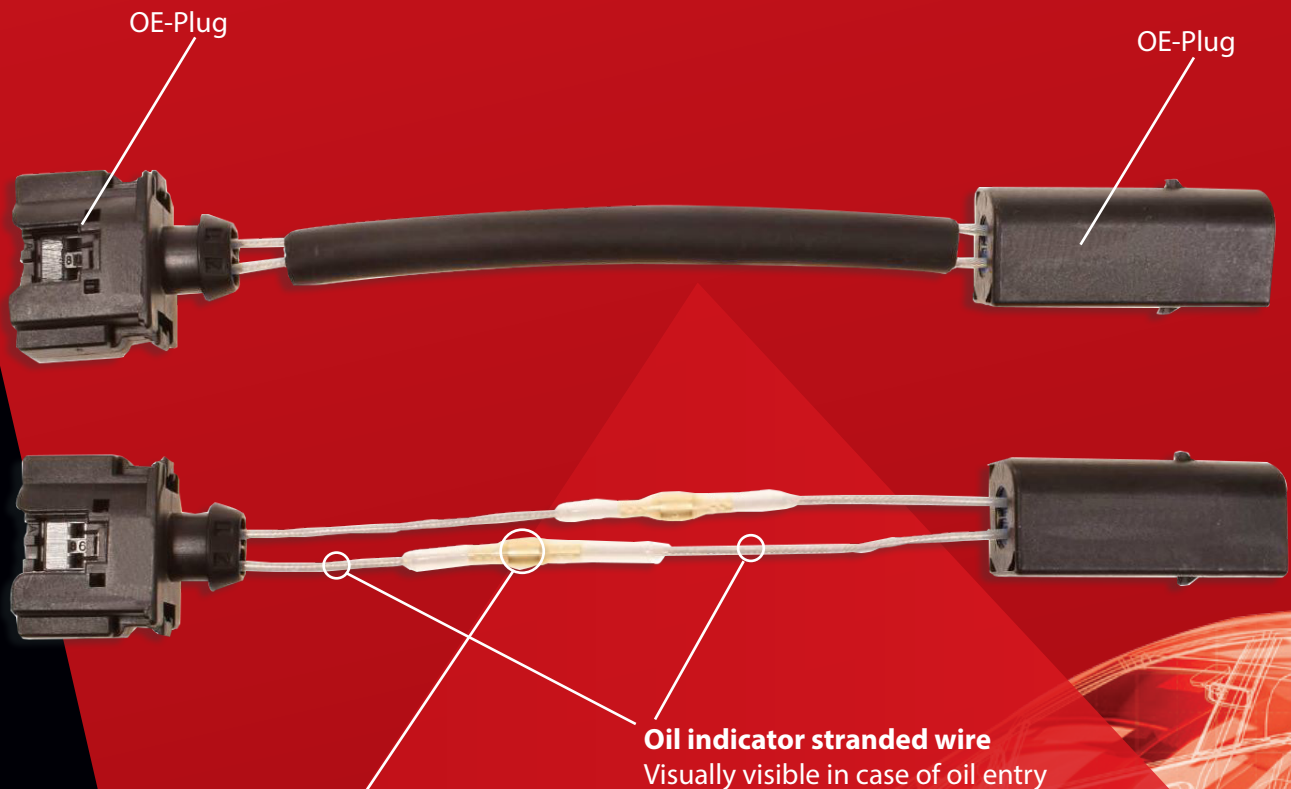
Oil stop line connector  
Oil indicator stranded wire

The loss of oil at the camshaft adjuster is a known problem with certain Mercedes-Benz engines. Due to the capillary effect, the oil in the wiring harness can reach the control unit. This can lead to failure of the electronics. The Metzger's „oil stop cable“ effectively prevents oil from penetrating the wiring harness.

#### Oil stop line connector

- Corrosion-free
- Connection technology according to
  - Standard DIN EN 60352-2
  - VW Norm Group Standard VW 60330
